### DAVID BROWN GETS BLUE CIRCLE SOUTHERN OUT OF A TIGHT SPOT

Overcoming extremely limited clearances while manoeuvring a 3m diameter, 23 tonne gear for Blue Circle Southern is just the latest example of the resourcefulness regularly shown by David Brown's on-site services team.

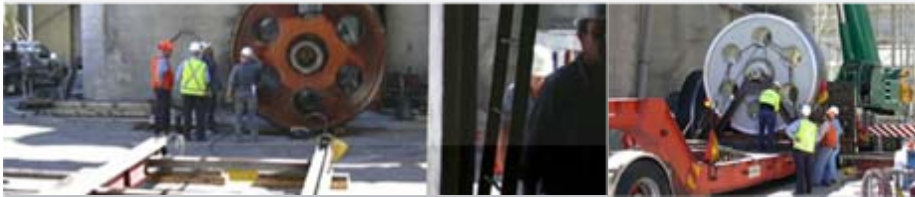
The cement mill gearbox operated by Australia's major cement producer had suffered a bearing failure and resulting debris damaged the gear teeth. Engineers from David Brown not only attended the site to make repairs and allow continued production in the interim, but liaised closely with the client to plan the gear replacement method and keep downtime to a minimum. The contract underlines the scope of David Brown's on-site services in a market which is increasingly driven by service as well as product excellence. In this case a special cradle was constructed under David Brown's guidance and the gear was transferred into place on rails.
